CALSPAN ON-SITE AIR BAG DEPLOYMENT INVESTIGATION

CALSPAN CASE NO. 95-09

VEHICLE #1 - 1992 FORD TAURUS GL STATION WAGON (AIR BAG EQUIPPED)

VEHICLE #2 - 1989 CHEVROLET S10 PICKUP TRUCK

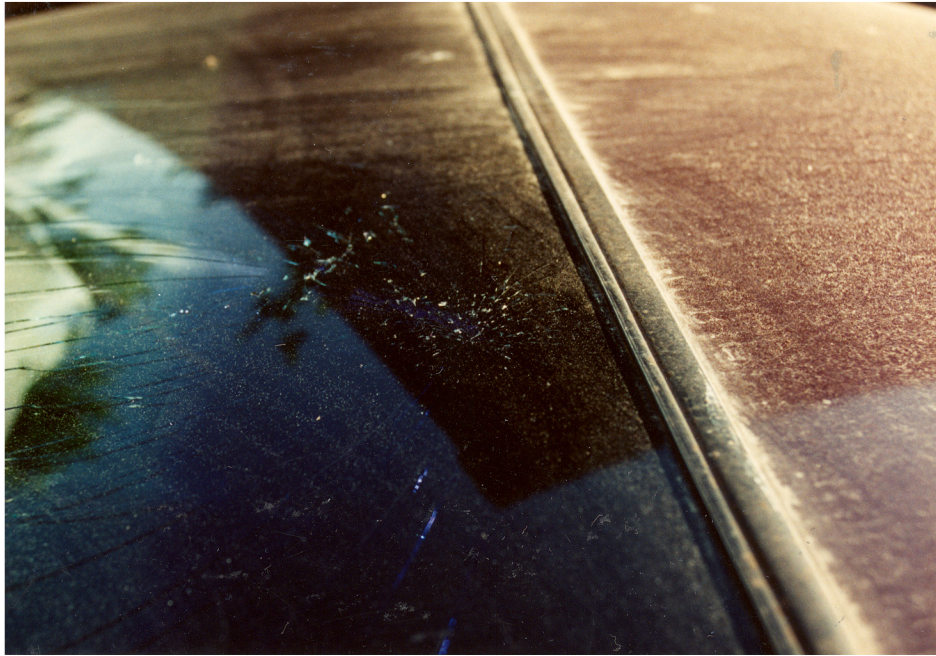
The windshield exhibited a spider web contact pattern which was consistent with an occupant hand contact. It was located 21.6 cm (8.5") left of the vehicle centerline and 11.1 mm (0.4") below the windshield header. Although the driver did not report any correlating lesion, this damage was probably caused by contact of the driver's right hand during the crash.

21. Close-up view of the interior contact evidence on the windshield near the windshield header.

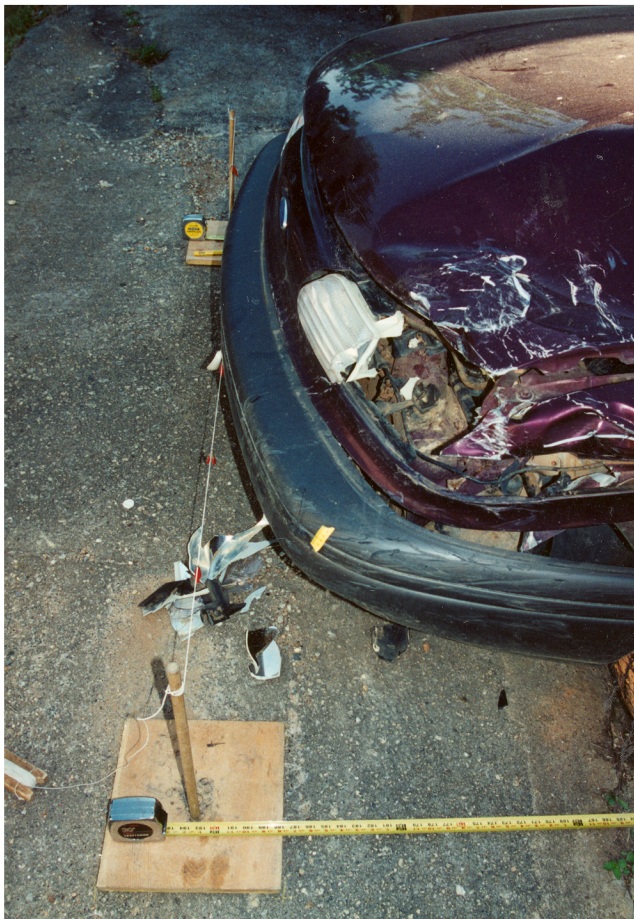
The frontal plane of the 1992 Ford Taurus GL station wagon struck the frontal plane of the 1989 Chevrolet S10 pickup truck. Direct contact was noted at the left front corner of the bumper surface, grille, and hood area. The front bumper sustained a maximum rearward displacement of 3.8 cm (1.5") and the left corner of the hood was displaced rearward a maximum of 38.1 cm (15.0"). The combined direct and induced damage length measured 139.7 cm (55.0") (refer to photographs #18, #19, #22 - #25 on pages A-9, through A-13). Measured crush values are listed below:

22. Lateral view showing the longitudinal displacement of the bumper and hood.

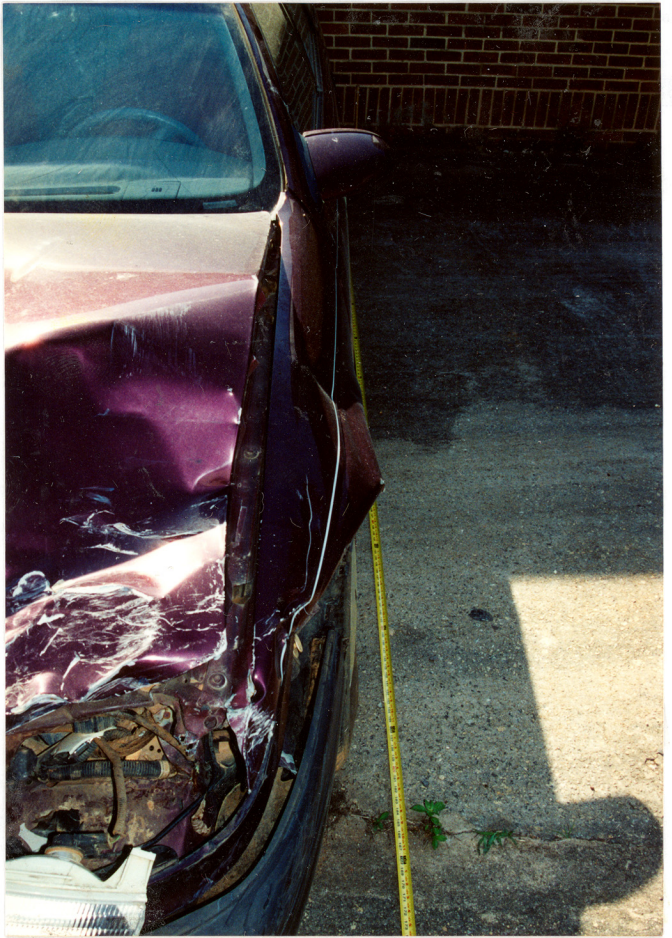
23. Longitudinal view along the left side plane.

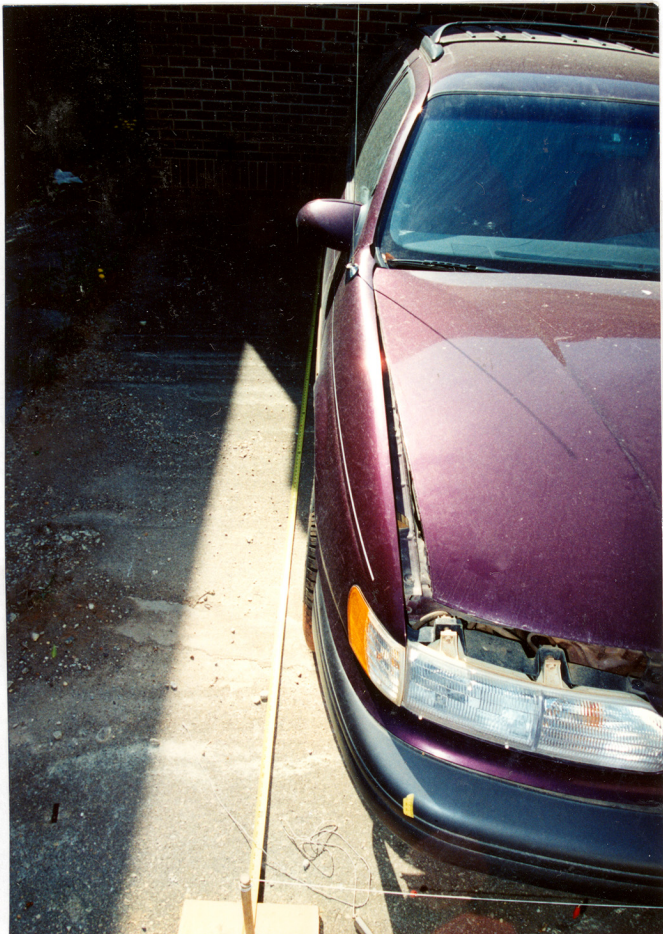
24. Longitudinal view along the right side plane.

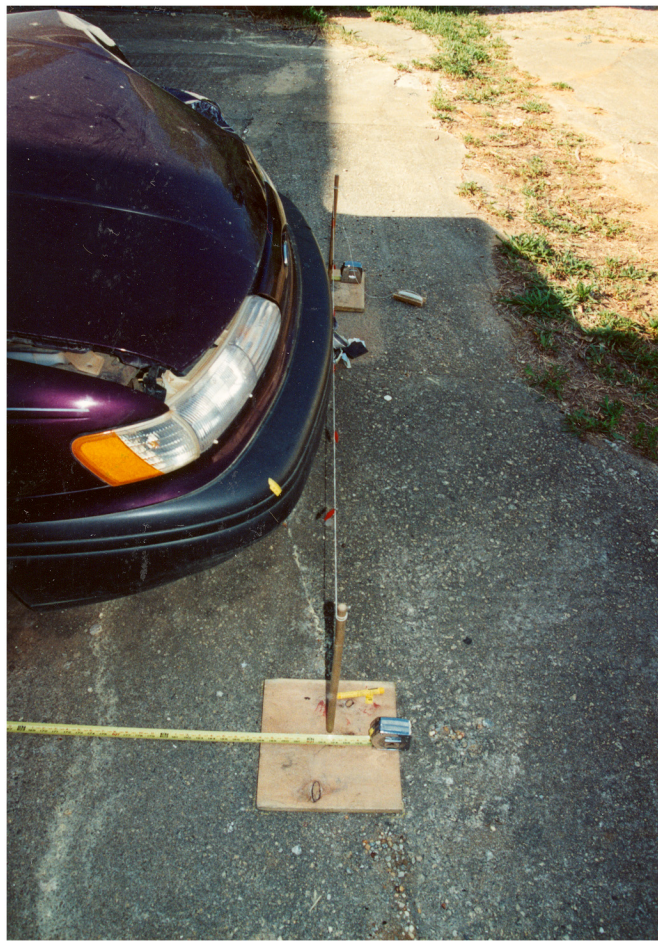
25. Lateral view from the right side of the vehicle showing the minimal longitudinal displacement of the bumper and hood.

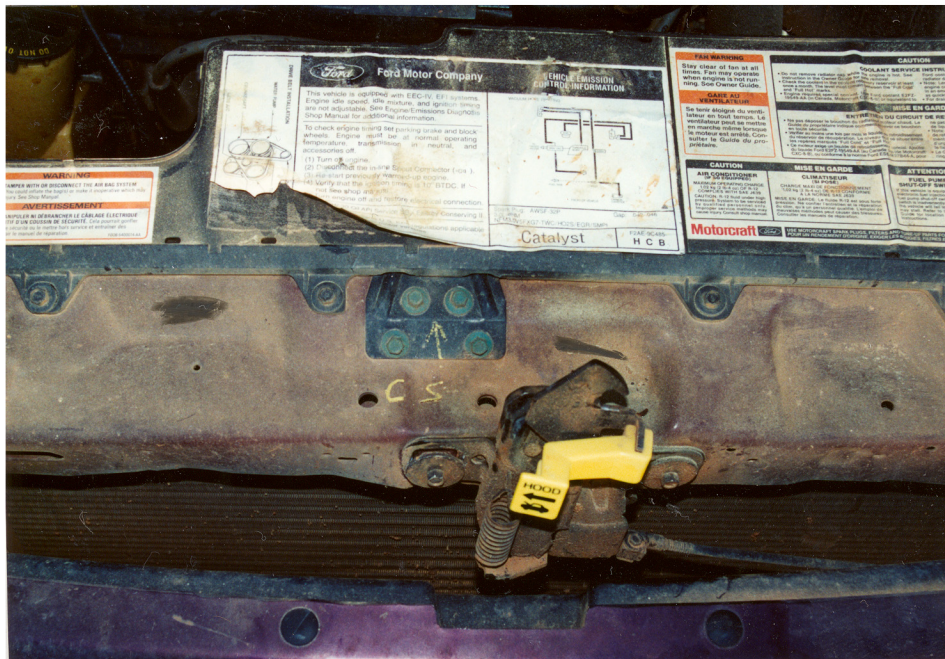
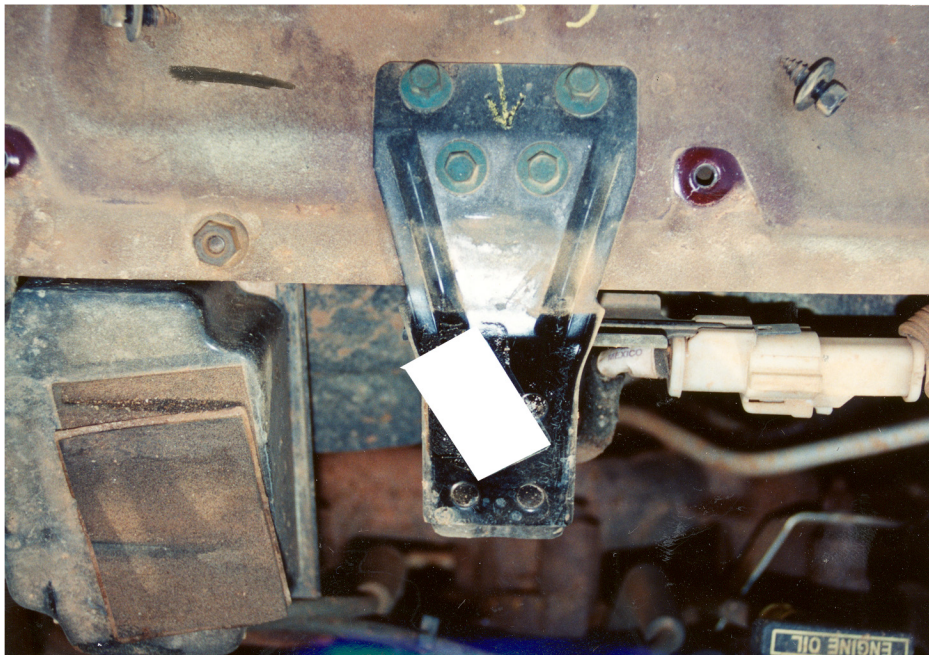
The forward most primary crash sensor in Vehicle #1 was located on the upper radiator support bracket 4.1 cm (1.6") right of the vehicle centerline. The sensor measured 5.7 cm (2.25") in length and 4.4 cm (1.75") in width and was hidden from normal view by the "Vehicle Emission Control Information" placard plate shown in photographs #27, #28 on page A-14. This sensor was not damaged in the crash.

27., 28. Views of the upper radiator support bracket showing the location of the crash sensor.

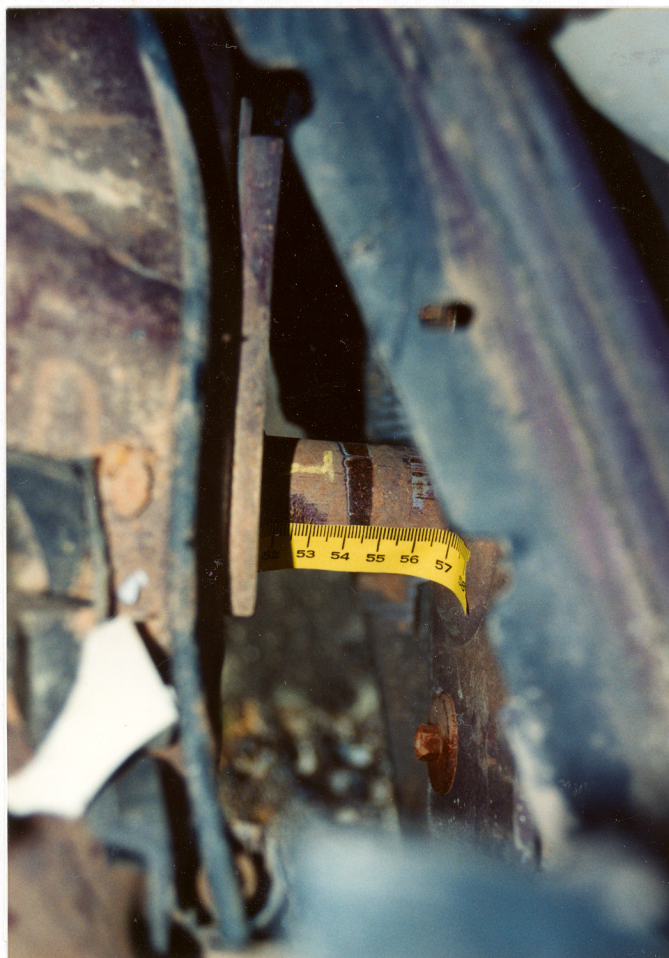
Components damaged in the crash included: the front bumper fascia, the grille; the left headlight and directional light assembly; the hood; the left front fender; the radiator; and the windshield. The left front bumper energy absorption device (EAD) was displaced rearward the full stroke value of 5.1 cm (2.0") with full restitution while the right EAD was not displaced (refer to photographs #29, #30 on page A-15).

29. View of the left bumper energy absorption device (EAD).

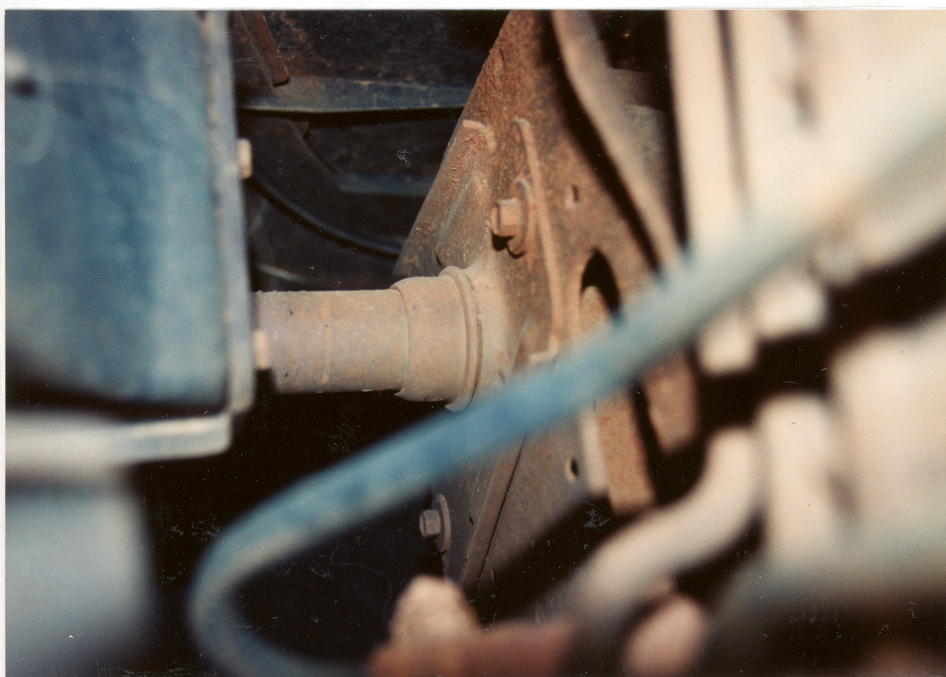
30. View of the right front bumper energy absorption device (EAD).

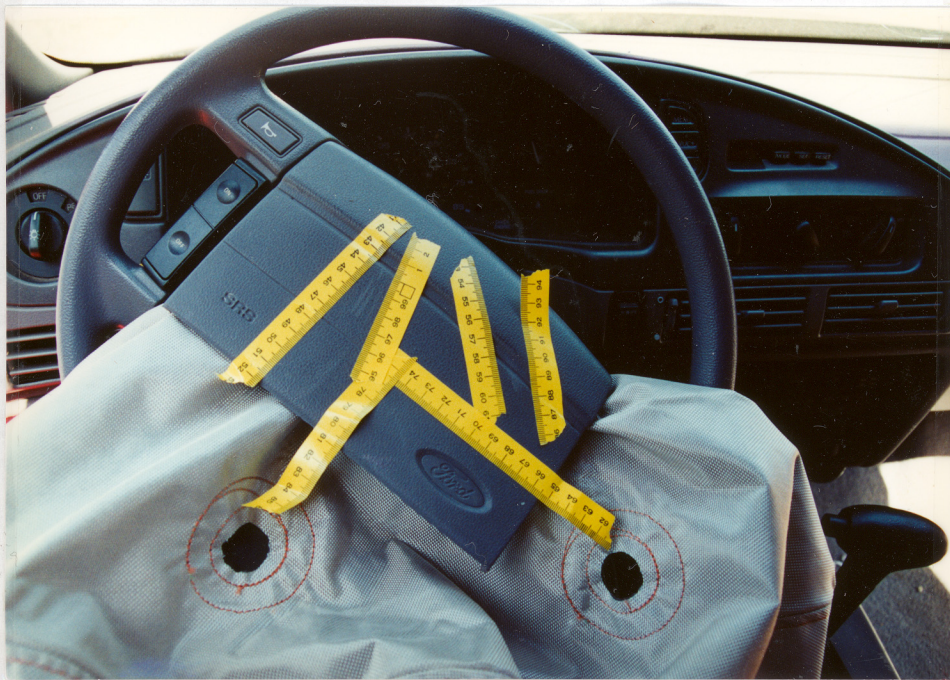
Damage to the interior was associated with driver contacts. The driver side air bag module cover exhibited several burnish marks and fabric coloration transfers (refer to photographs #44 - #46 on pages A-22, A-23). A dark blue/black transfer was observed along the entire upper cosmetic relief line which was located 3.0 cm (1.2") below the top of the upper flap. This transfer was consistent in color with the color of the driver's shirt (refer to photographs #57, #58 on page A-29).

The air bag module flaps exhibited several burnish marks and fabric coloration transfer marks (refer to photographs #44 - #46 on pages A-22, A-23) from contact with the driver during the deployment sequence. A dark blue/black transfer was observed along the entire upper cosmetic relief line located 3.0 cm (1.2") below the top of the upper flap which was consistent in color with the color of the driver's shirt (refer to photographs #57, #58 on page A-29). A significant burnish mark which measured 8.9 cm (3.5") vertically and 3.1 cm (1.25") laterally was located 3.1 cm (1.25") right of the left vertical tear seam and began at the horizontal tear seam line.

44. View of the driver side air bag module cover and the air bag vent ports located on the reverse side of the air bag.

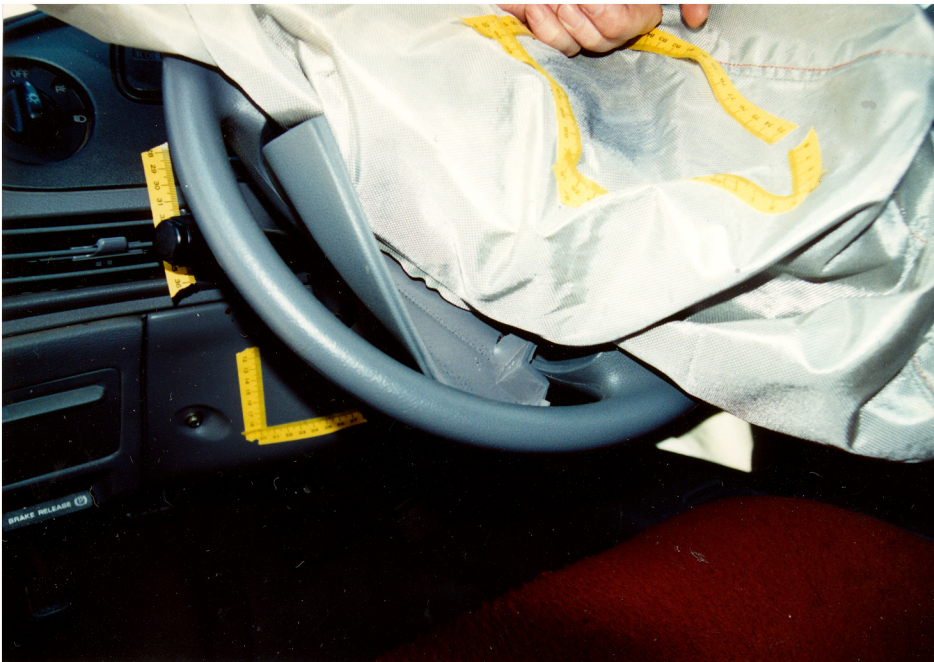
The lower air bag module flap exhibited a dark color burnish mark along the horizontal seam line (refer to photographs #47, #48 on page A-24). The mark measured 12.7 cm (5.0") laterally and 7.9 mm (0.3") vertically and began at the left vertical tear seam line. Refer to the diagram on page 12 for a detailed schematic of the contact evidence on the driver side air bag module cover.

The lower air bag module flap exhibited a dark color burnish mark along the horizontal seam line (refer to photographs #47, #48 on page A-24). The mark measured 12.7 cm (5.0") laterally and 7.9 mm (0.3") vertically and began at the left vertical tear seam line. Refer to the diagram on the page 12 for a detailed schematic of the contact evidence on the driver side air bag module cover. The right side of the flap was displaced forward beyond the steering wheel rim as the result of the air bag deployment sequence and the loading by the unrestrained driver on the air bag (refer to photographs #47, #48 on page A-24).

47., 48. Views showing the position of the lower air bag module flap and the contact evidence along the horizontal tear seam line of the flap.

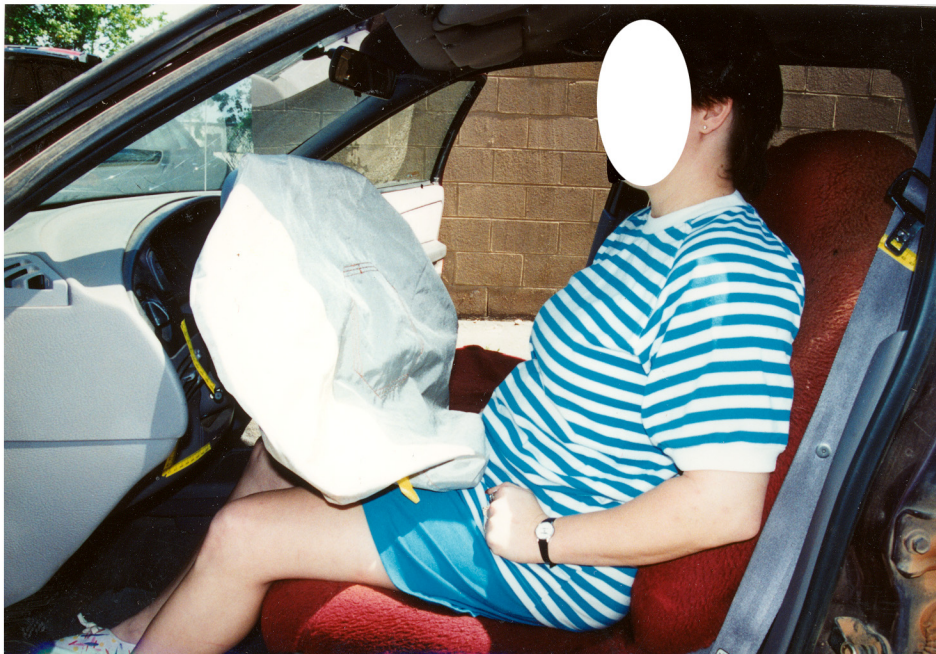
52. Lateral view of the front seat with the driver seated in her simulated driving position.

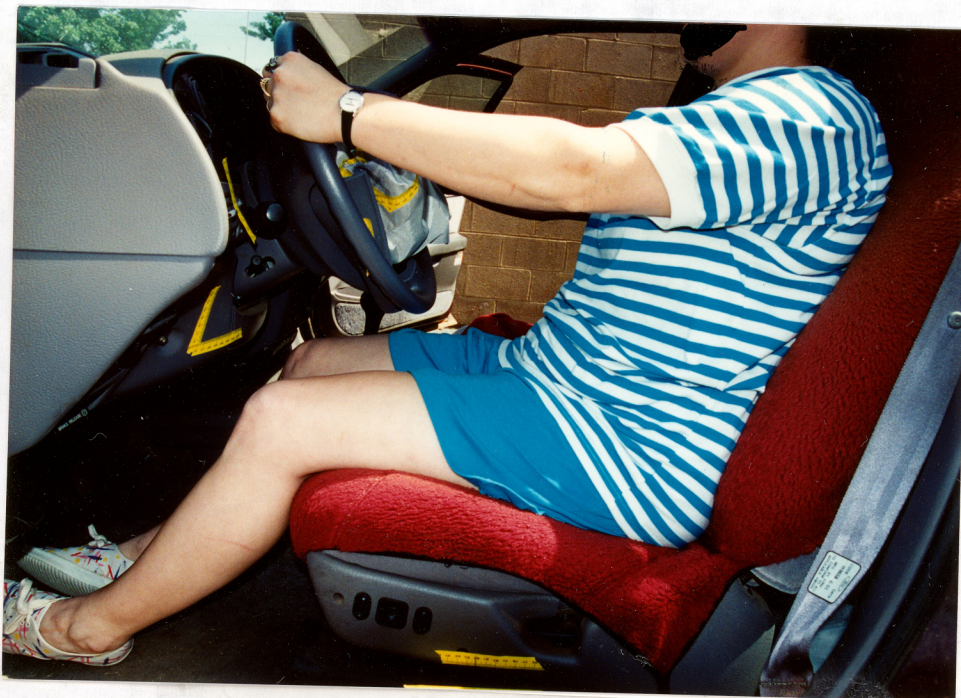
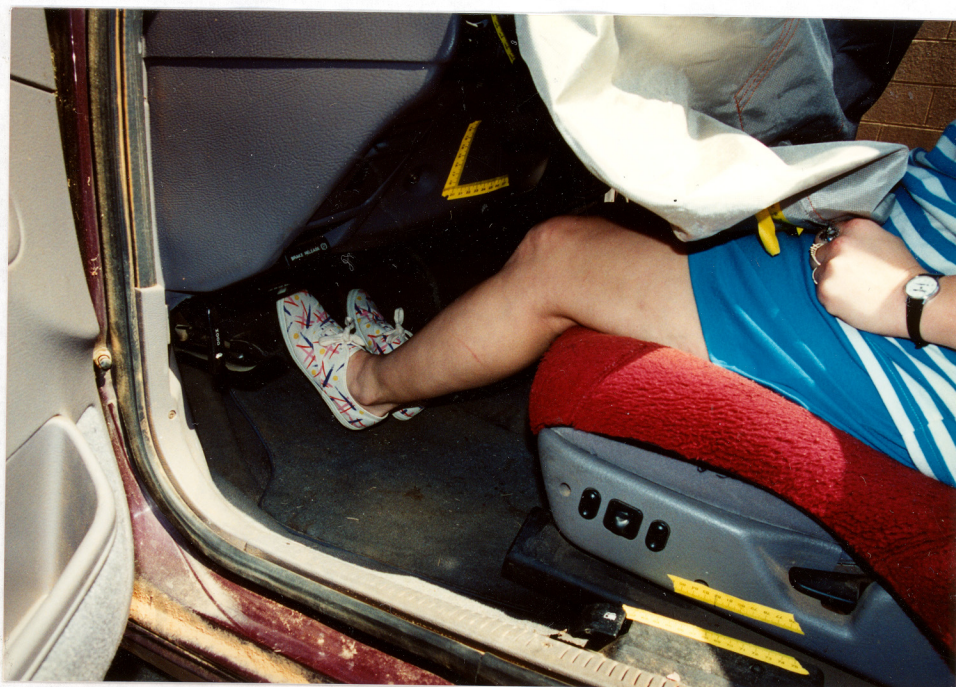
53., 54. Views showing the location of the driver's torso and lower extremities with respect to the air bag, steering wheel rim, and lower instrument panel.

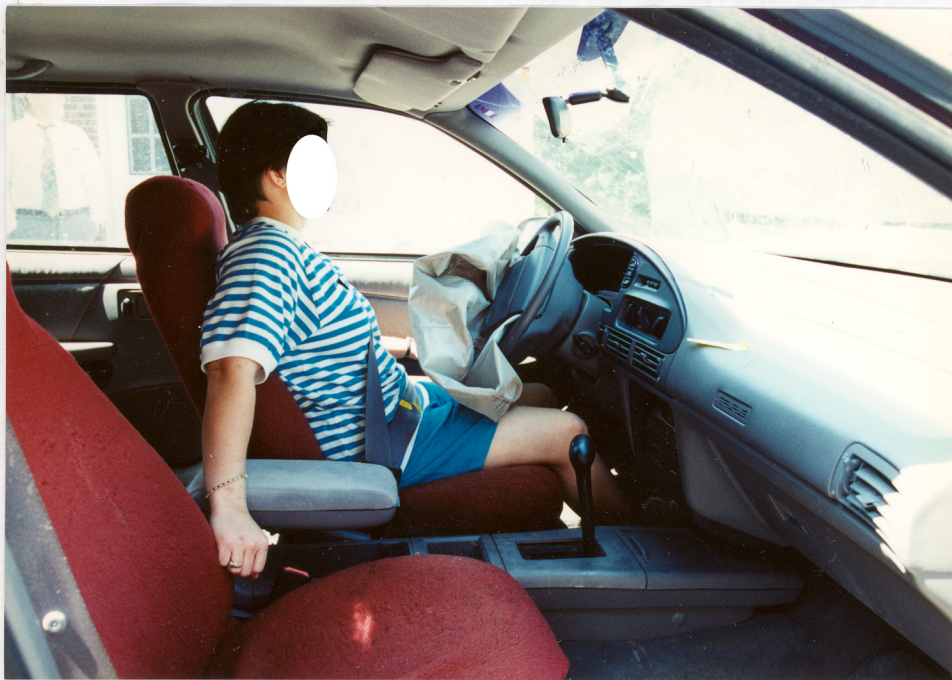
55. View of the driver's seated position from the right side of the vehicle.

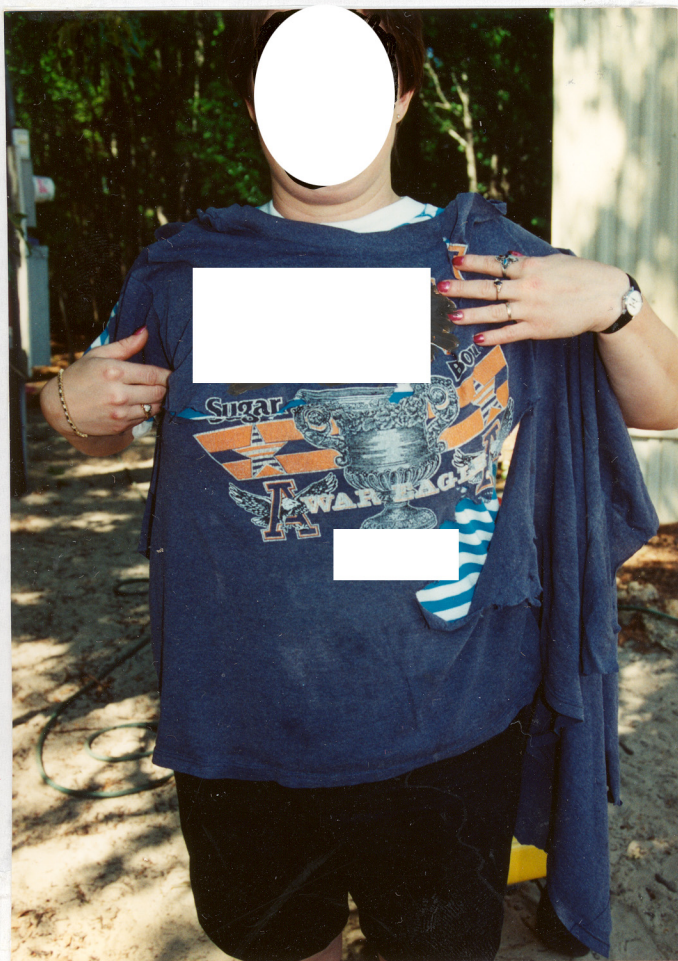
This contact was associated with the 17.1 cm (6.75") long angular rip noted on the driver's shirt located 30.5 cm (12.0") above the bottom and 20.3 cm (8.0") left of the centerline of the shirt. It extended downward to a point 13.3 cm (5.25") above the bottom and 6.4 cm (2.5") left of the centerline (refer to photographs #56 - #58 on pages A-28, A-29).

56. View of the shirt worn by the driver at the time of the crash.

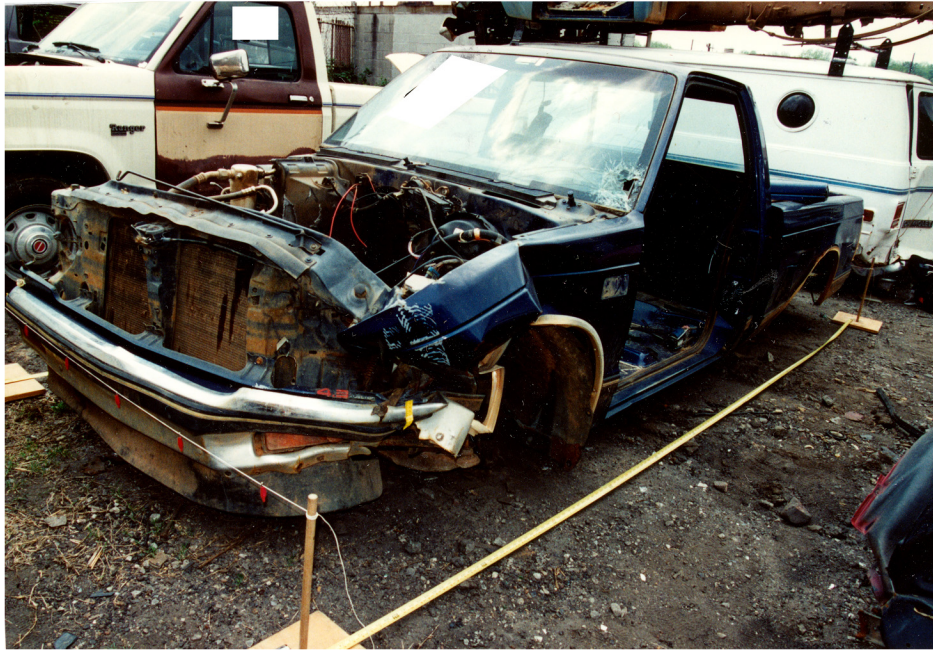
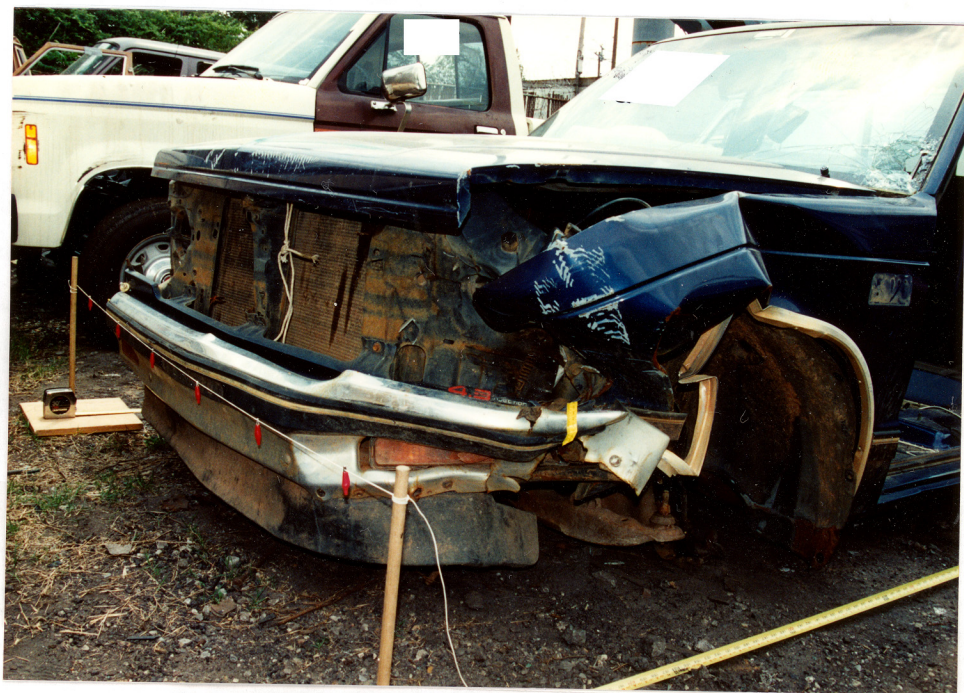
73., 74. Left front corner views.

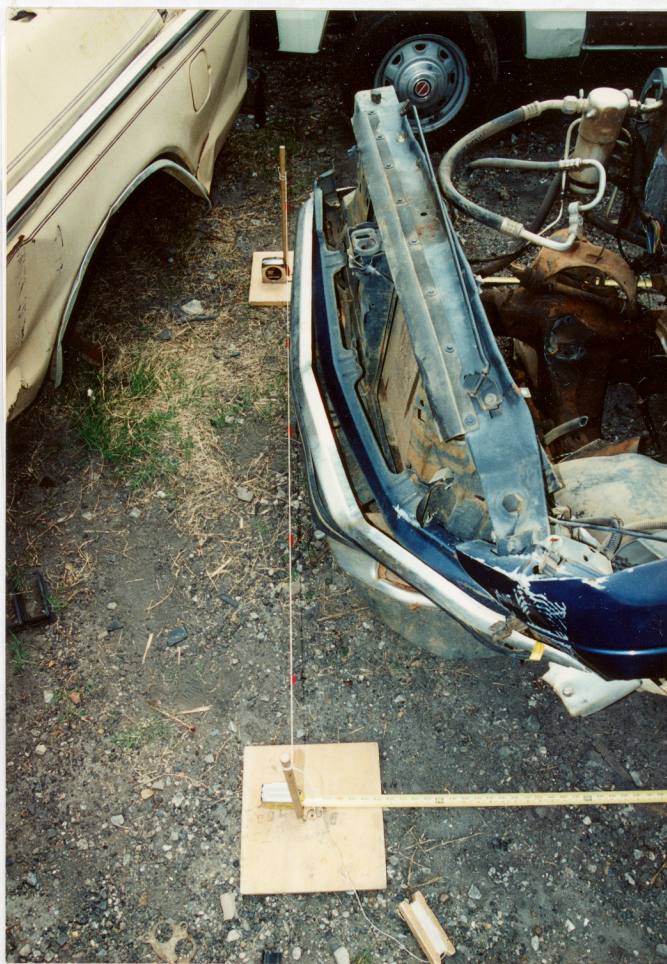
75. Lateral view of the front plane from the left side of the vehicle showing the extent of rearward crush.

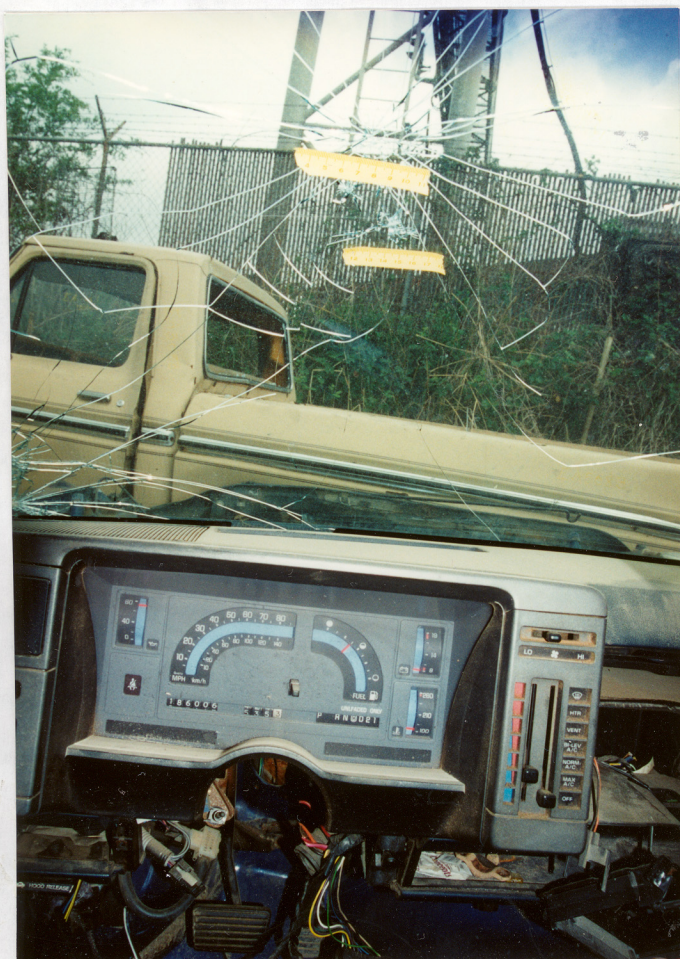
82. View of the left side instrument panel and windshield.

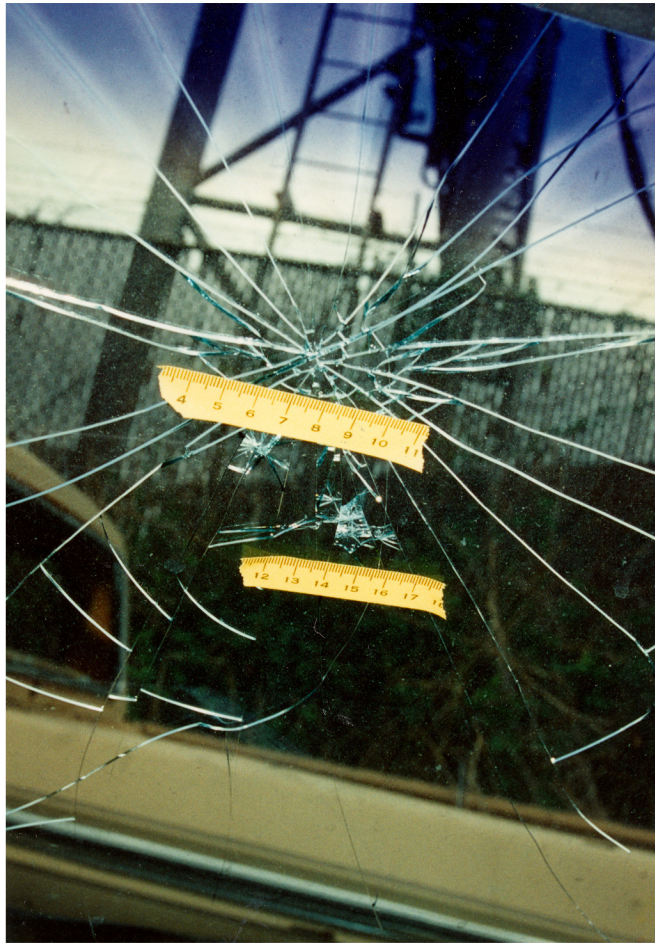
The driver's right hand was propelled upward by the air bag and struck the windshield adjacent to the windshield header as noted by the typical spider web contact pattern. The driver complained of a swollen right hand which was attributed to this contact mechanism.

84. Close-up view of the hole in the windshield glazing.
